## Central Valley Regional Water Quality Control Board

**Date:** 2/20/13

**Subject:** Inspection of Sierra Pacific Industries' Ponderosa Post-Fire Sediment Study, Shasta County, California

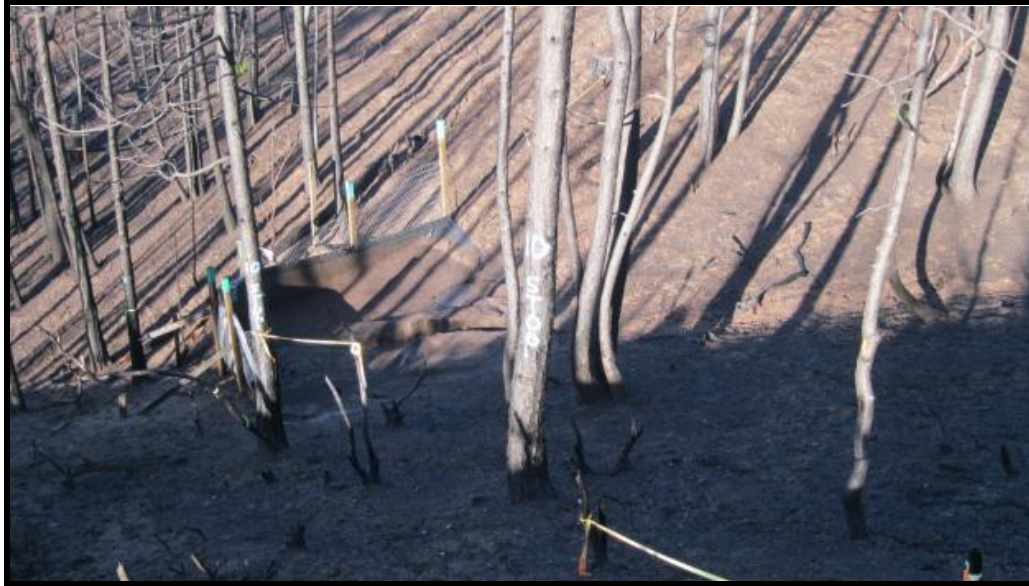
**Fence #10 (Control):** I estimated the mass of sediment in the fence at several thousand pounds (Figure 1). The eroded material appears to be primarily from extensive rilling and channel incision (Figures 2, 3, 4).

**Figure 1.** Sediment deposition in fence #10.

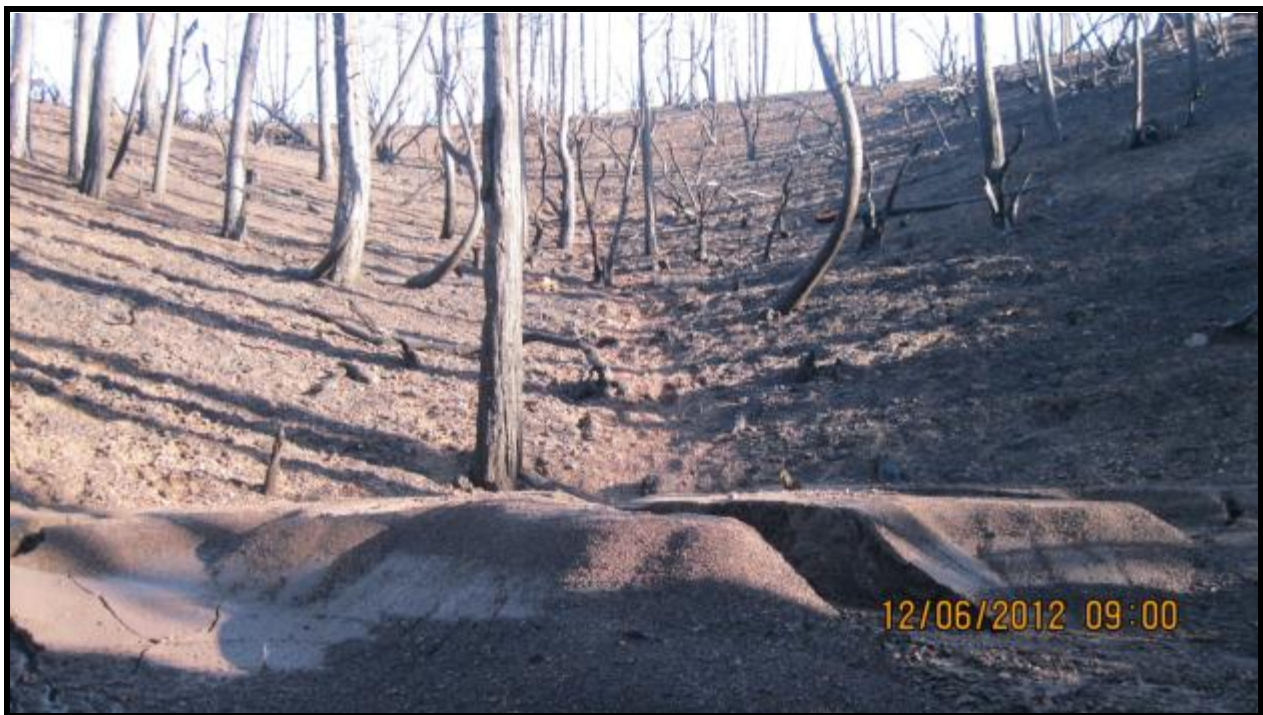
**Figure 2.** Depositional lobe at the front of fence #10. Channel incision is evident in the axis of the swale directly above the center of the deposit.

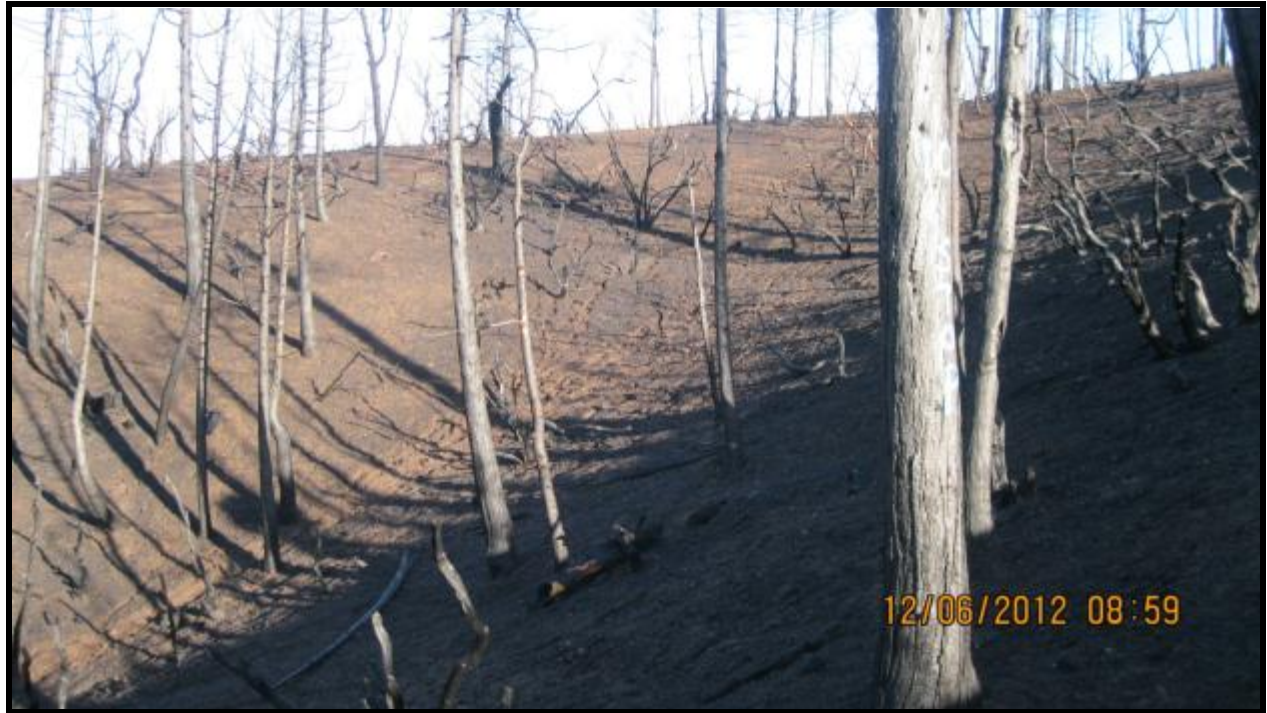
**Figure 3.** Converging rill networks at the head of the swale above fence #10. Channel incision occurs below the point of convergence.

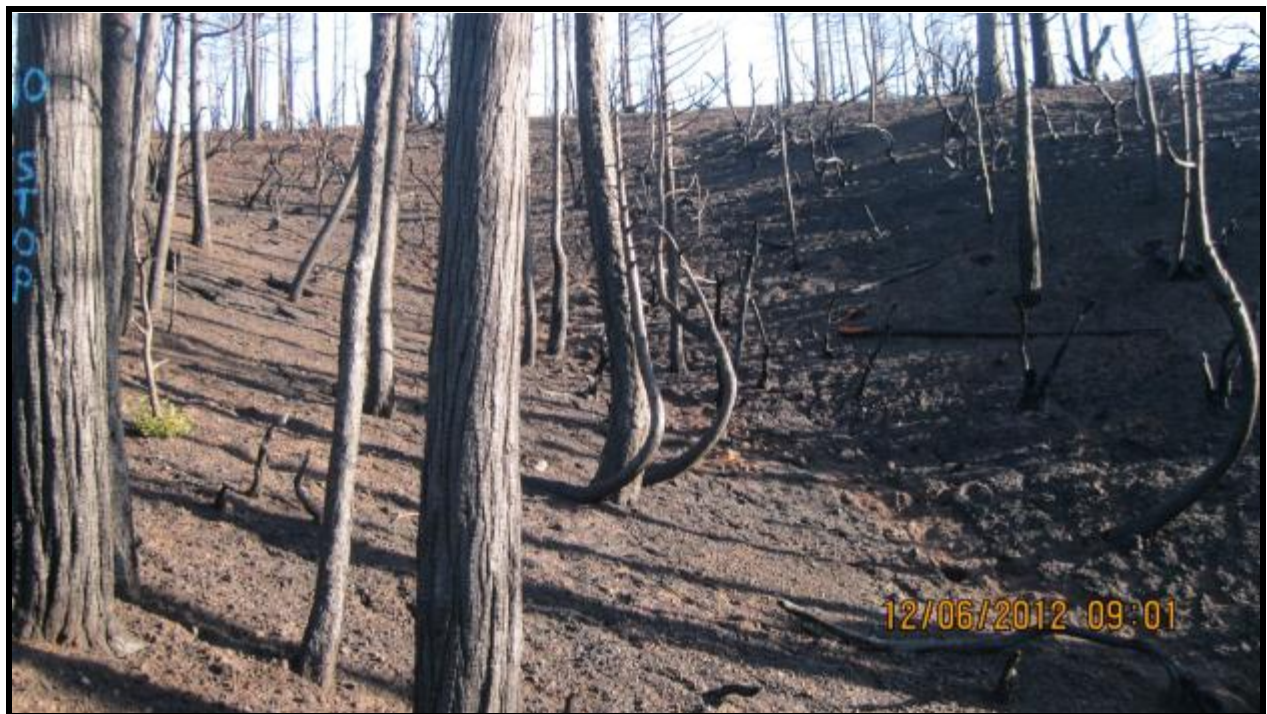
**Figure 4.** Rill erosion and channel incision above fence #10.

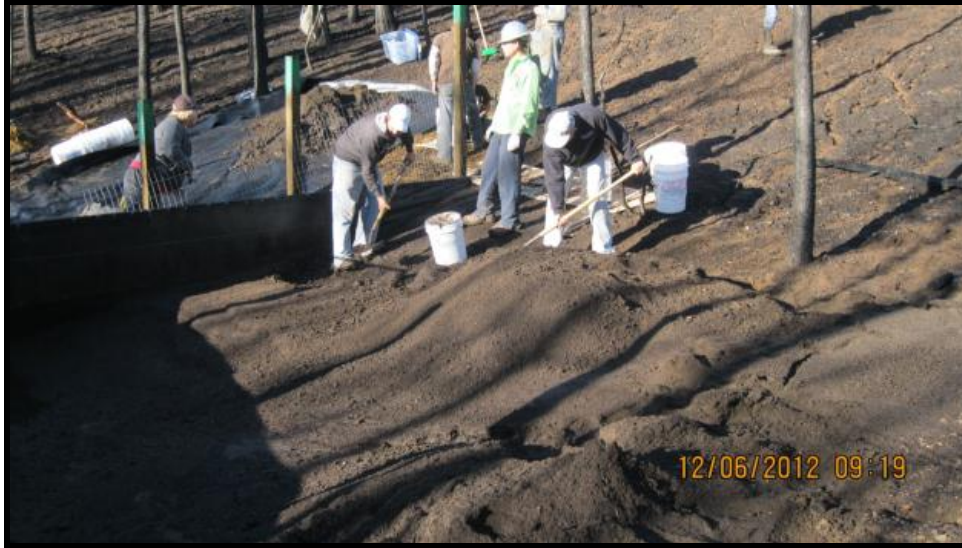
**Fence #9 (Control)** - I estimated the mass of sediment in the fence at several thousand pounds (Figure 5). The eroded material appears to be primarily from extensive rilling and channel incision (Figures 2, 3, 4).

**Figure 5.** Laborers excavating sediment from fence #9.

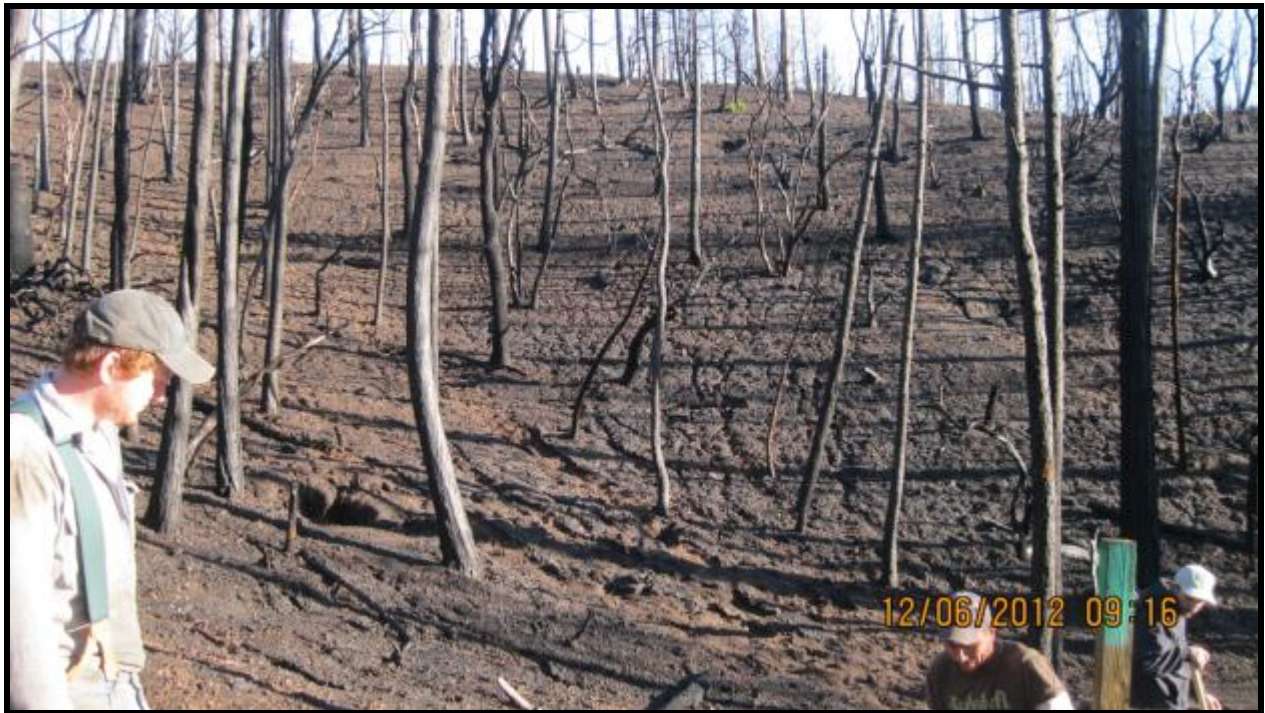
**Figure 6.** Extensive rill erosion above fence #9.

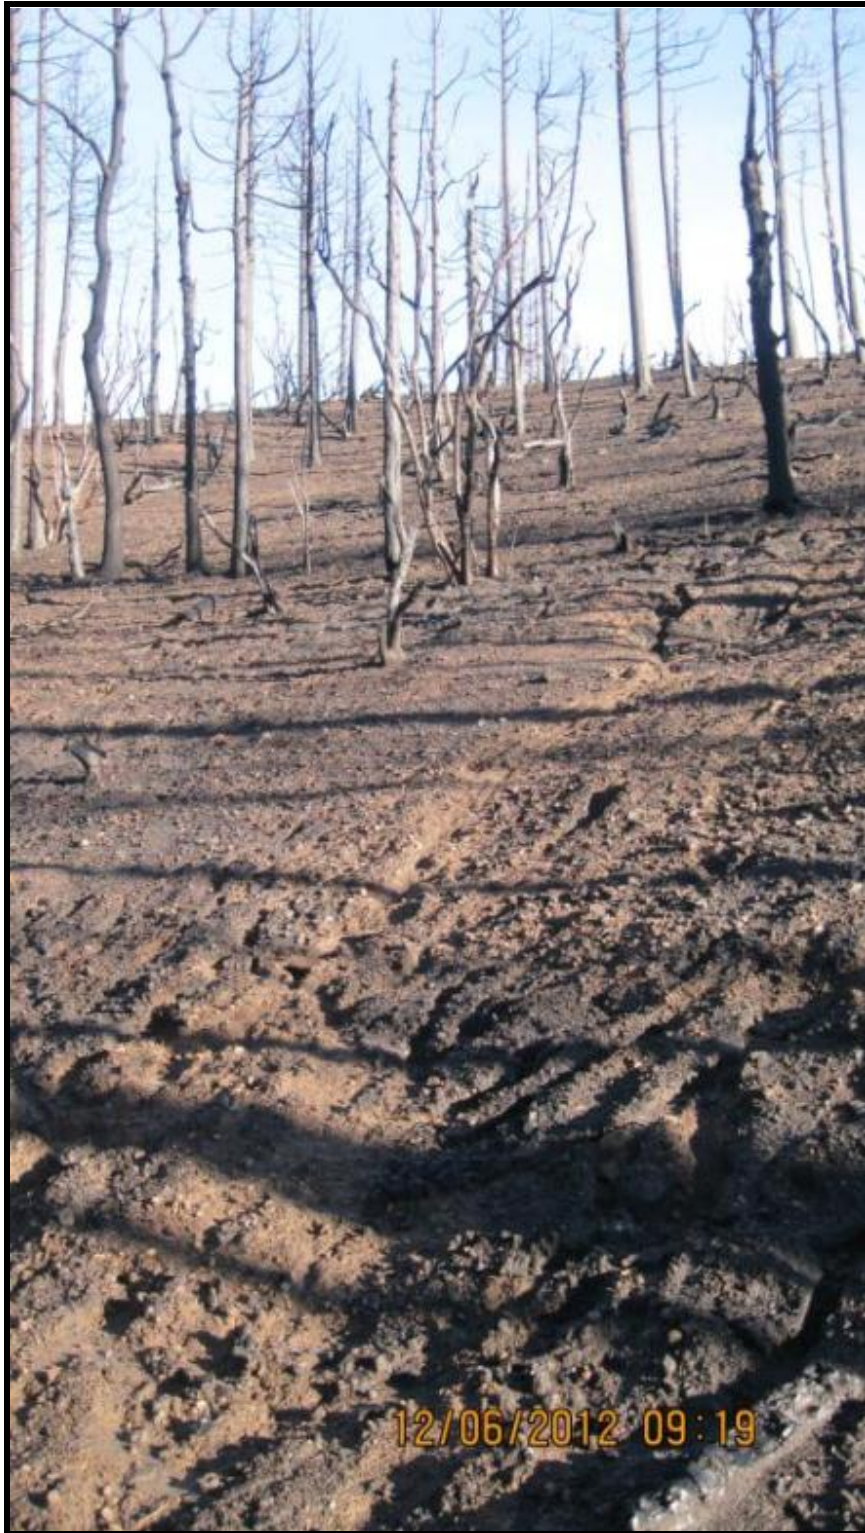
**Figure 7.** Rilling above fence #9. Note the coarsening of the hillslope surface due to sheetwash erosion.

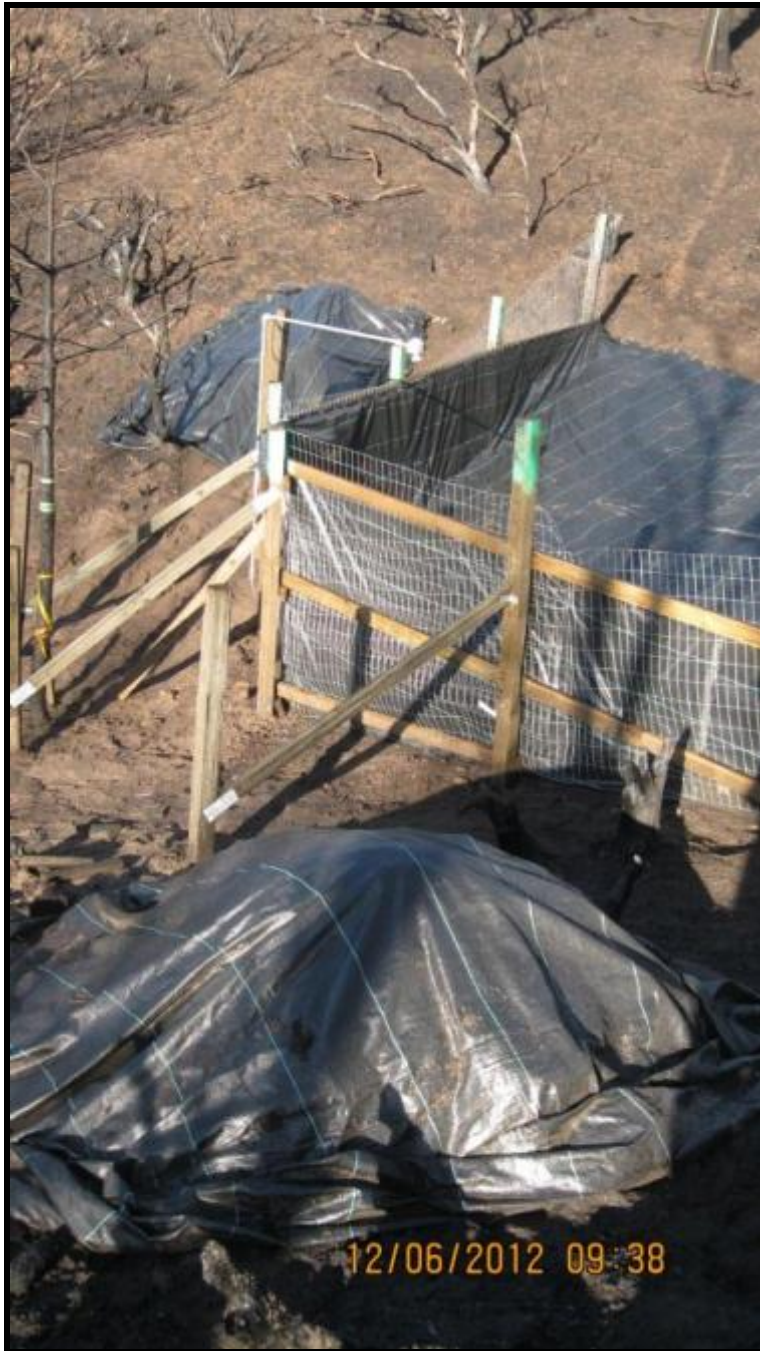
**Fence #8 (Control)** - The fence was excavated prior to my arrival due to the near overtopping and buckling of the fence during the storms. The excavated material had been wrapped in sediment fence fabric and appeared to be several thousand pounds worth of material (Figure 8). The eroded material appears to be primarily from extensive rilling and channel incision (Figures 9, 10, 11, 12).

**Figure 8.** Excavated material from fence #8 wrapped in sediment fence fabric.

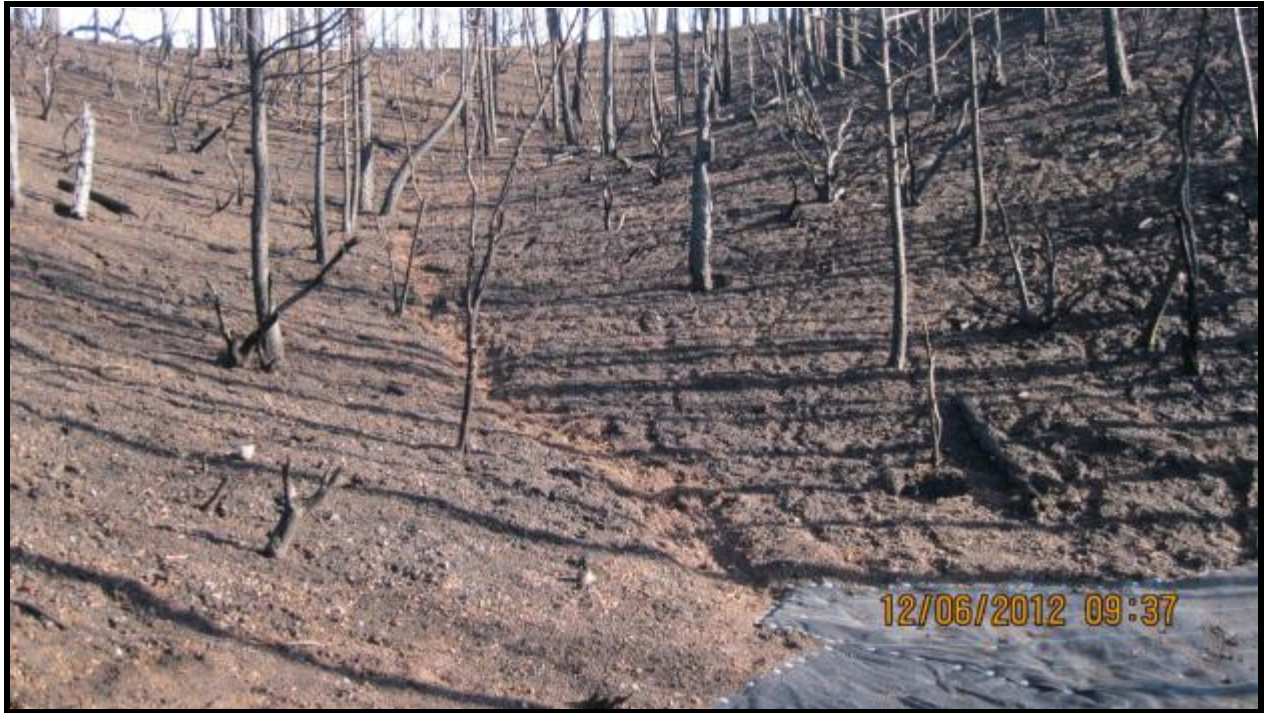
Figure 9. Channel incision and extensive rilling above fence #8.

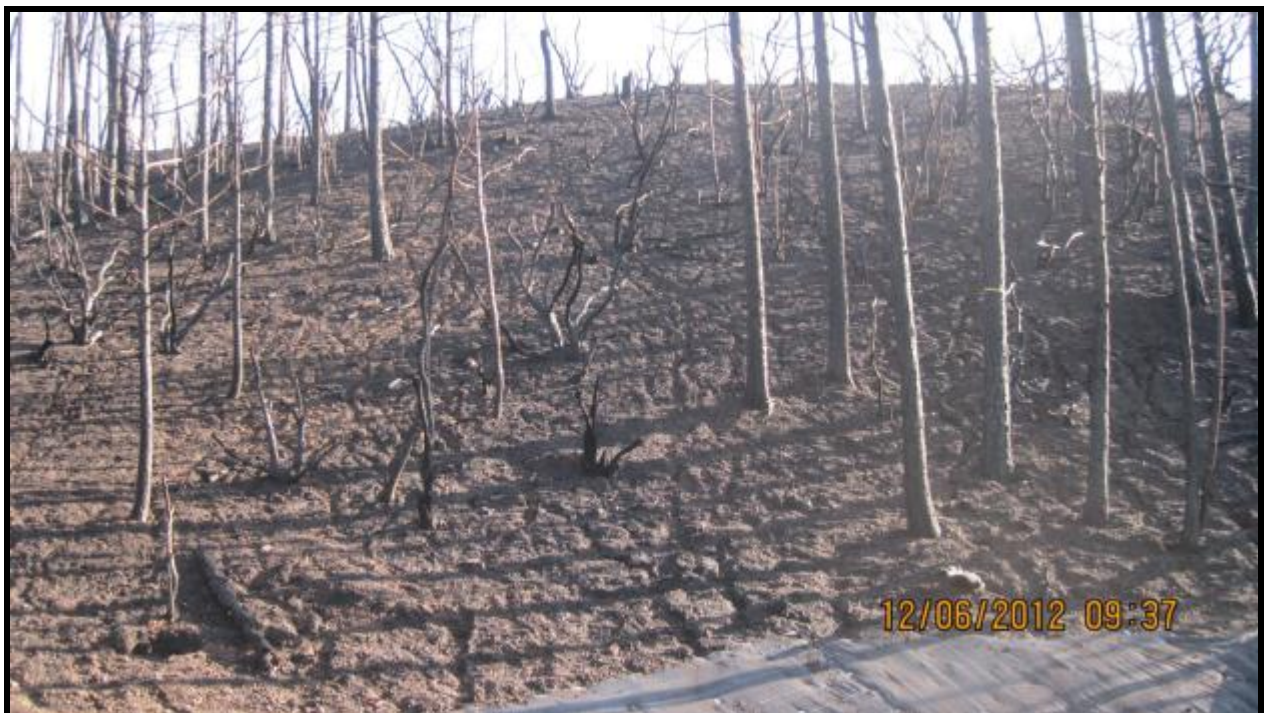
Figure 10. Rill erosion above fence #8

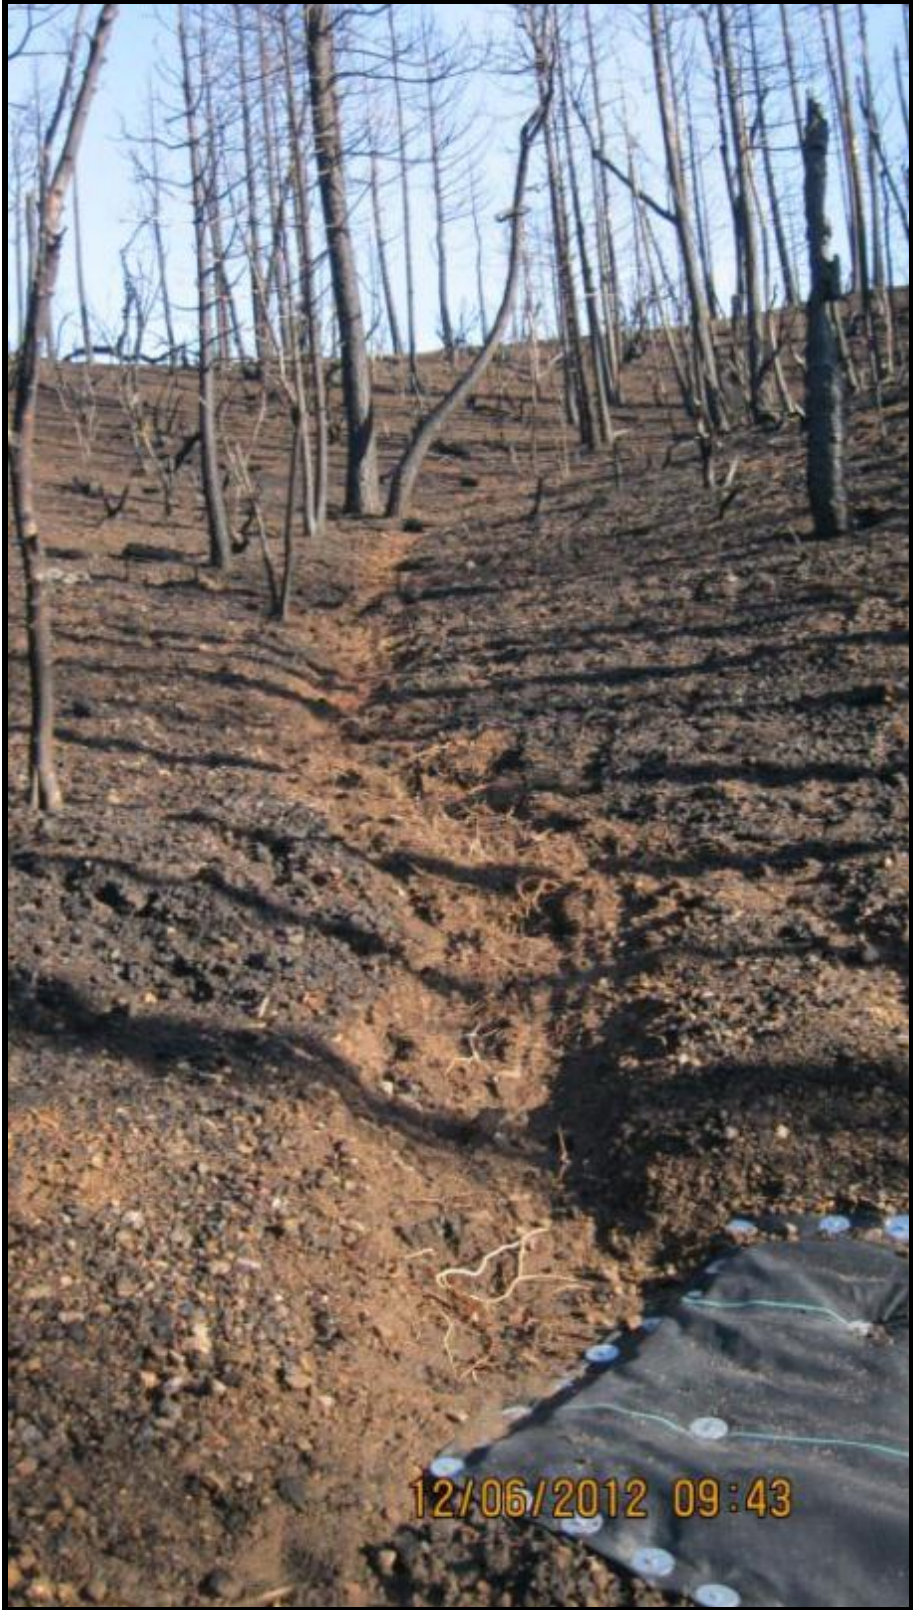
Figure 11. Channel incision above fence #8.

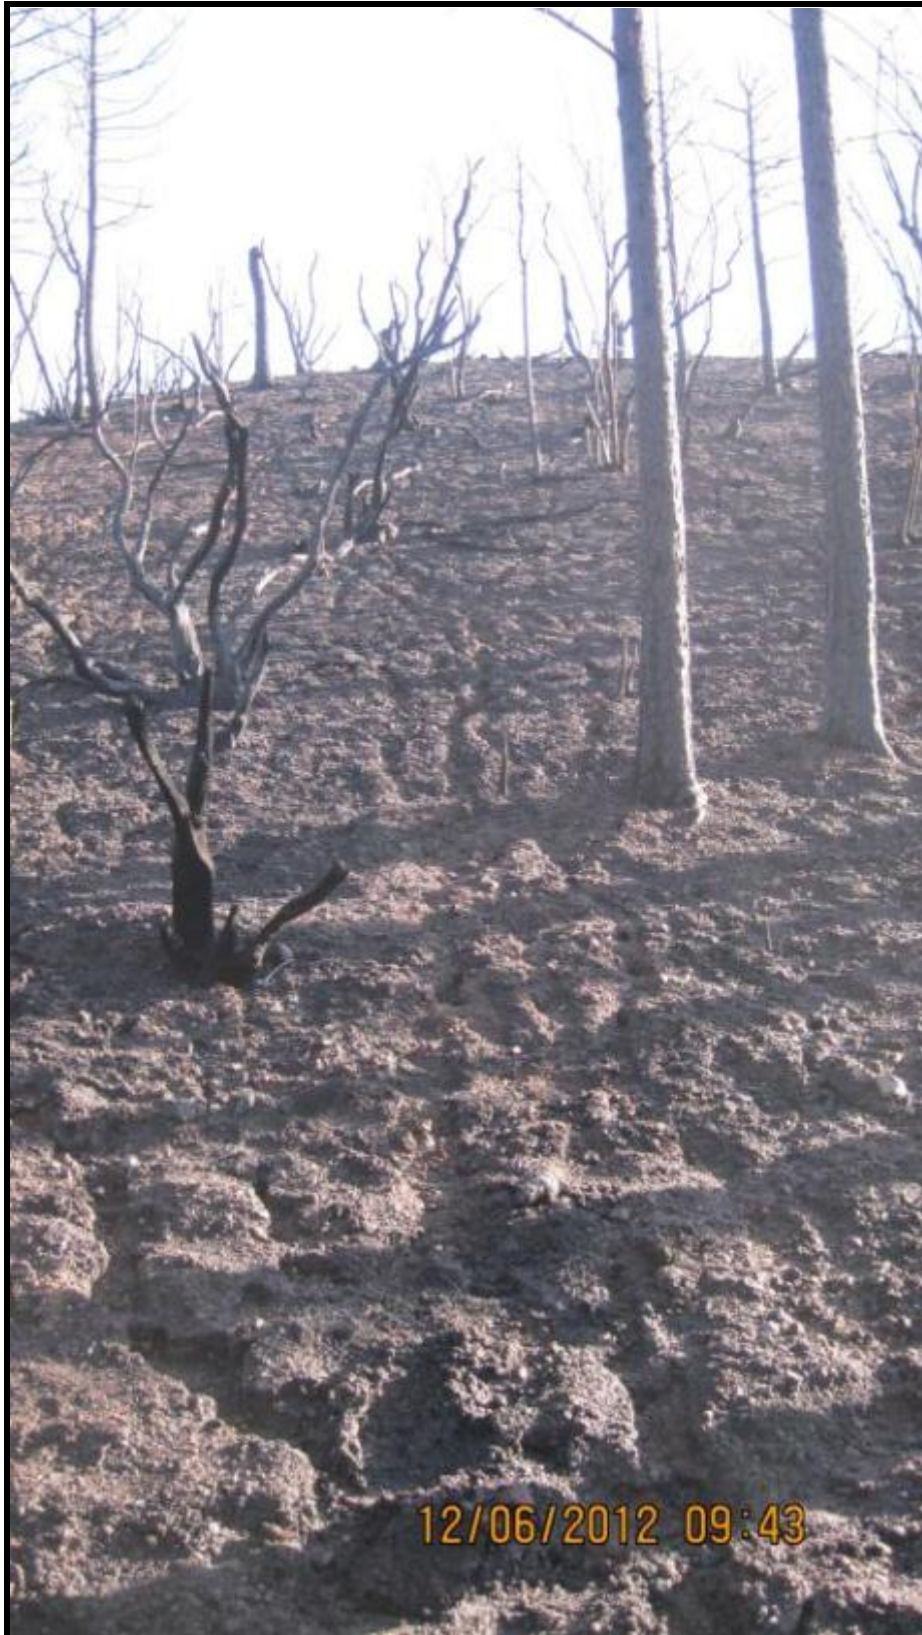
**Figure 12.** Rill erosion above fence #8.

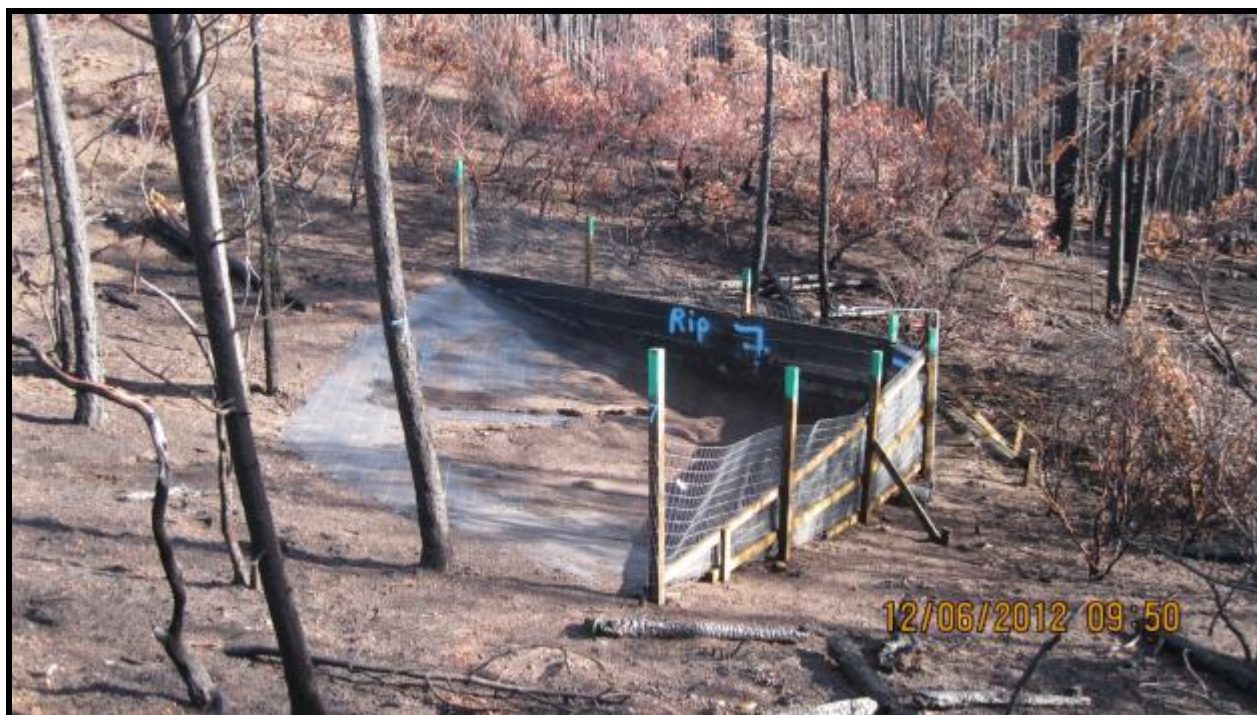
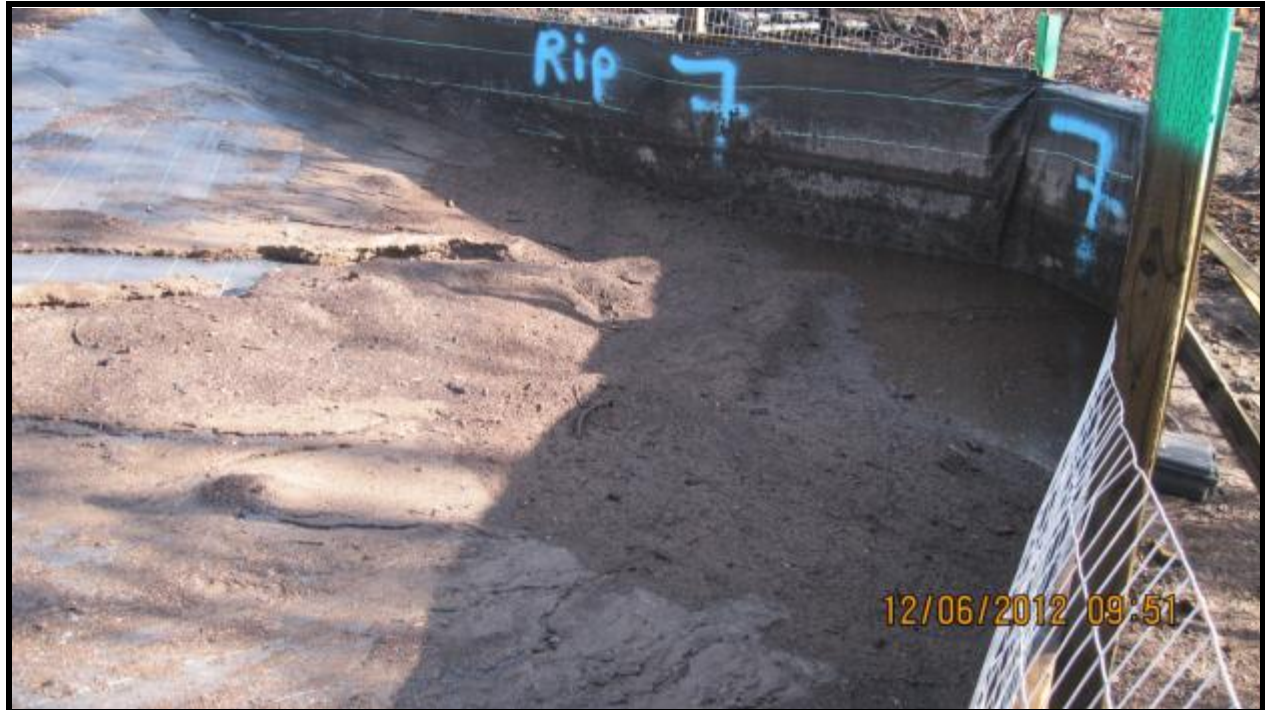
**Fence #7 (Logged, Standard Salvage, and Contour Ripped)** – The deposited material in the fence was estimated at approximately 100 pounds (Figures 13 and 14), and the grain size of the deposited material was noticeably finer than the material in the control fences. The limited amount of erosion appears to be due to flowpath modification and increased roughness from the contour ripping. Contour ripping limited slope length, which in turn reduced the likelihood of rill erosion (Figure 15). Much of the material eroded via sheetwash was deposited in the contour furrows (Figure 16). Since the ripping was not done exactly on contour, runoff from furrows was directed to the axis of the swale. This resulted in limited channel incision in the lower part of the swale.

**Figure 13.** Sediment deposition in fence #7.

**Figure 14.** Sediment deposition in fence #7.

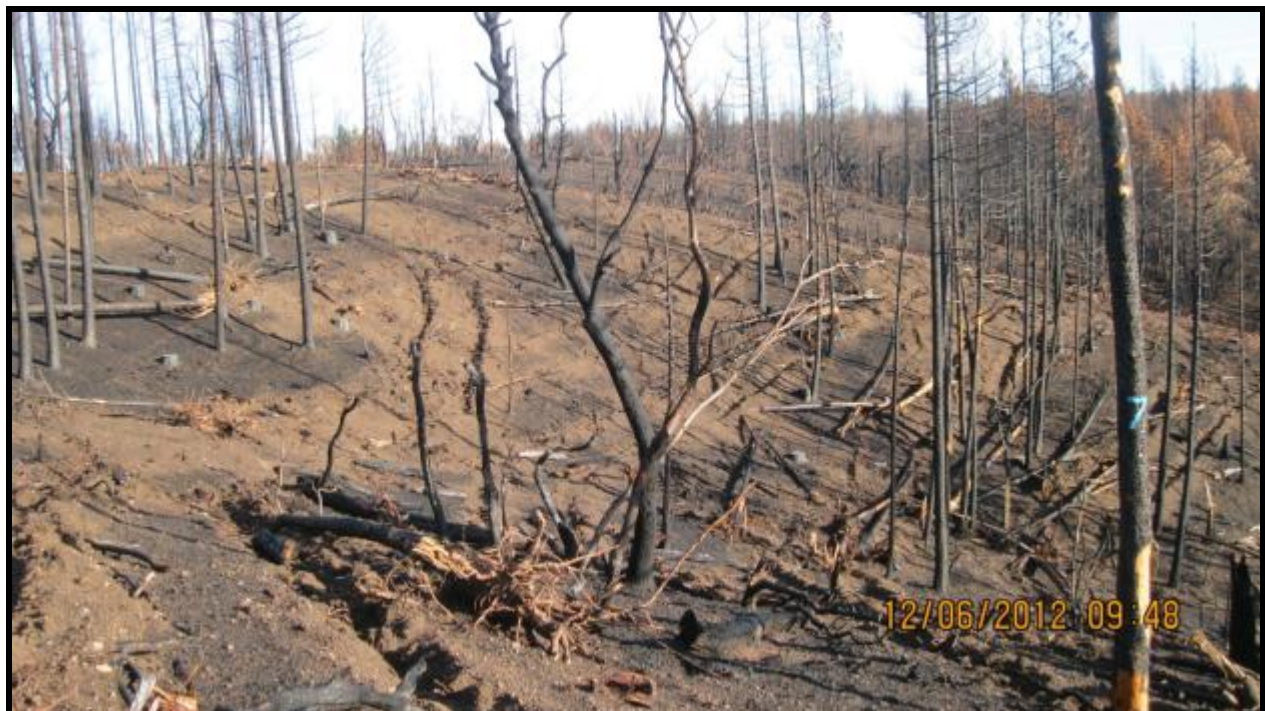
**Figure 15.** Contour ripping above fence #7.

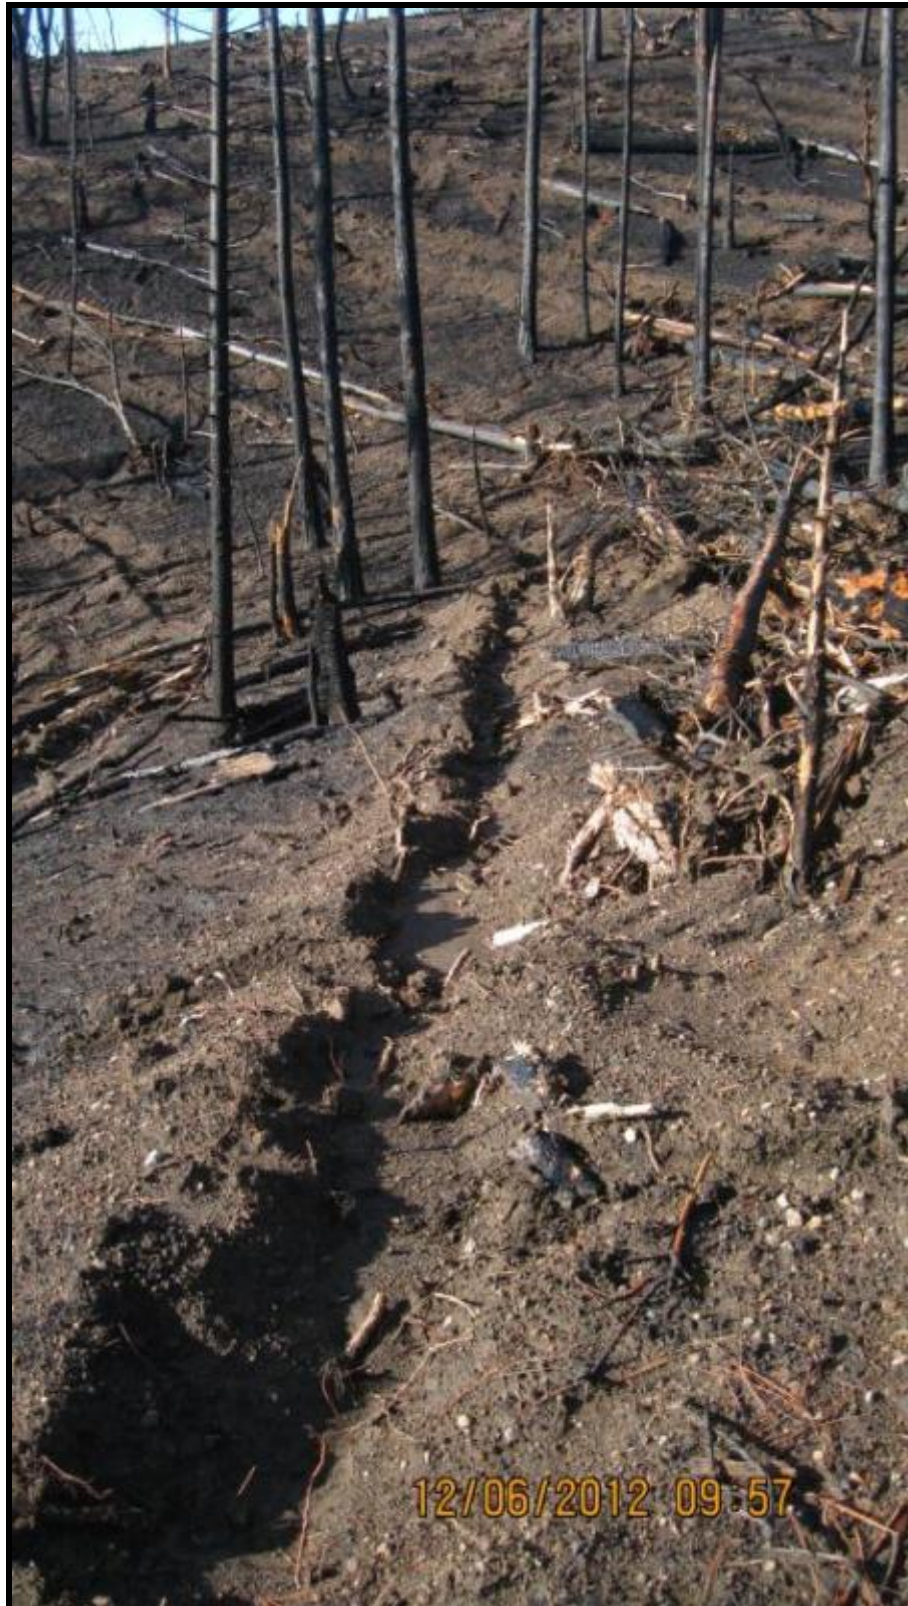
**Figure 16.** A contour furrow above fence #7. Sheetwash from the hillslope was deposited in the furrow. Very limited rilling was observed between furrows.

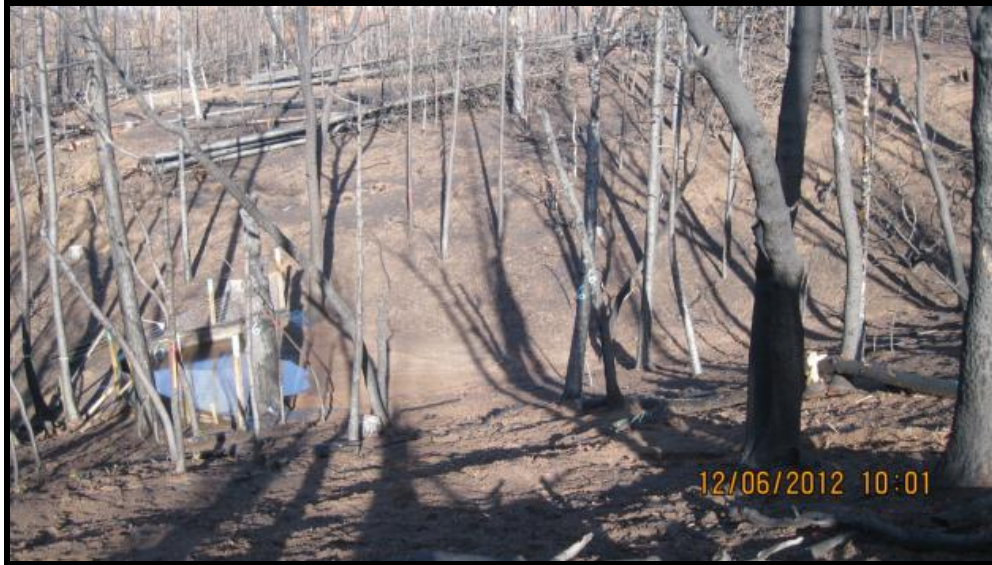
**Fence #6 (Logged and Standard Salvage)** - It was difficult to estimate the mass of deposited material in the fence due to ponded water (Figures 17 and 18). However, after probing the ponded water with a stick, I estimated the relatively shallow depth of deposition to indicate several hundred pounds of sediment. Despite the fact that the swale was logged with ground-based equipment, there were relatively few tracks from the equipment (Figure 19), indicating that surface roughness was not significantly enhanced by the logging equipment. The relatively low mass of sediment in the fence can be attributed to the lower rates of rill erosion and channel incision (Figure 20).

**Figure 17.** Looking down at fence #6. Note the ponded water in the sediment fence.

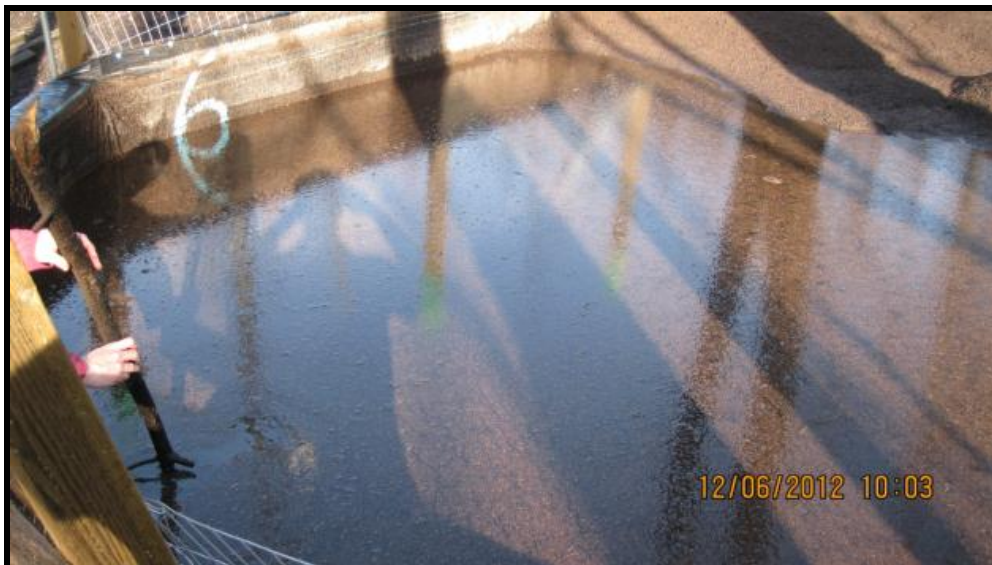
**Figure 18.** Ponded water at fence #6. Probing with the stick indicated a relatively small mass of deposited sediment.

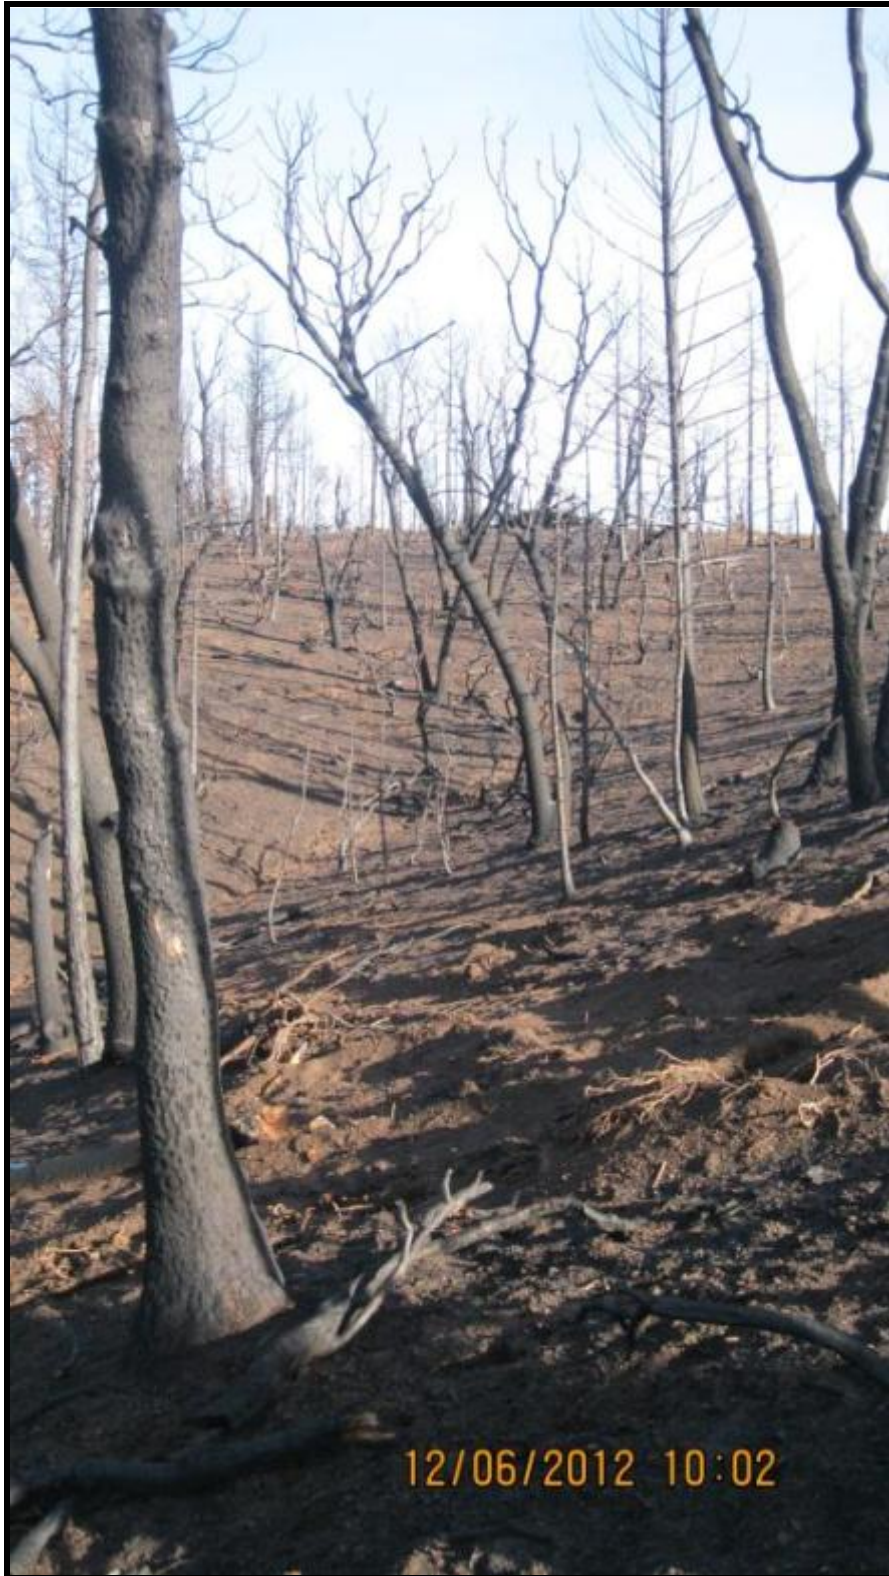
**Figure 19.** Equipment tracks from ground-based logging.

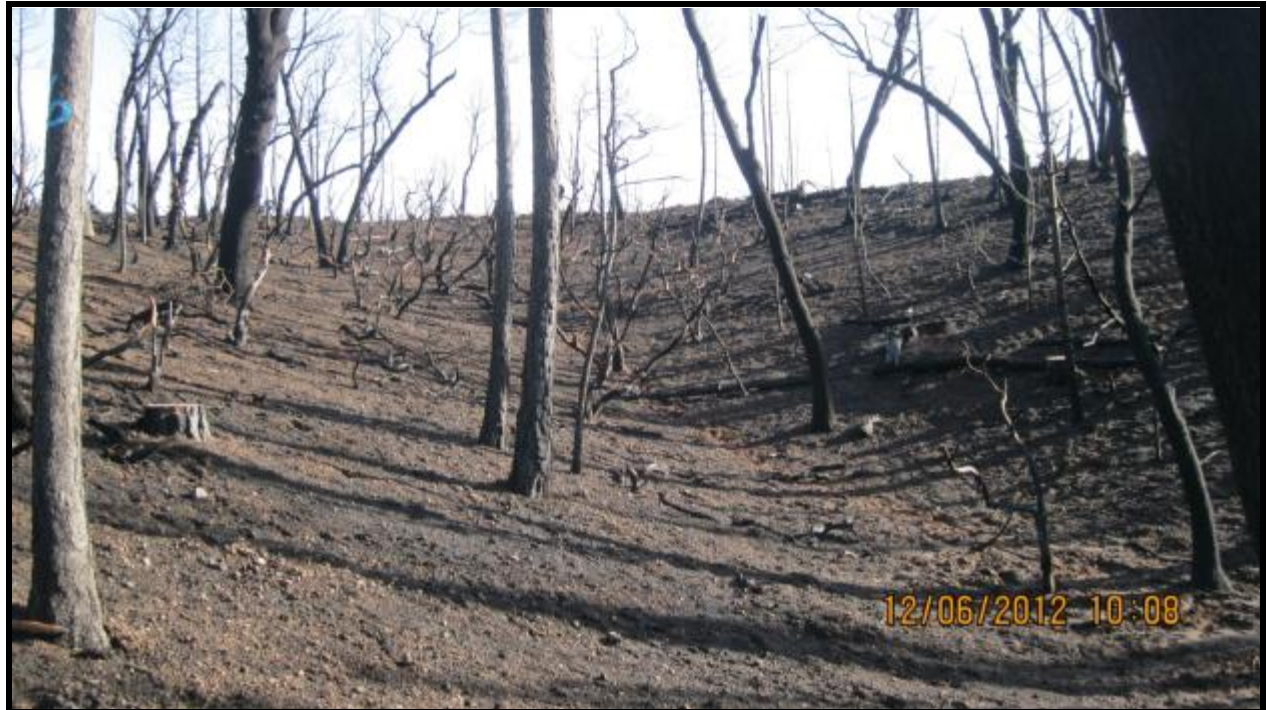
**Figure 20.** Hillslopes above fence #6. Note the relative lack of rilling and channel incision.

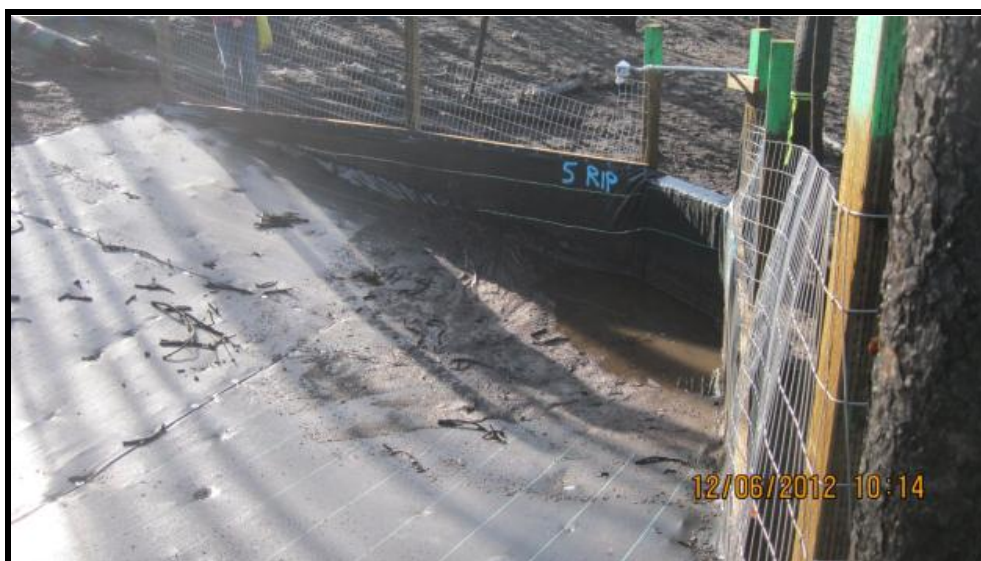
**Fence #5 (Logged, Standard Salvage, and Contour Ripped)** - The deposited material in the fence was estimated at approximately 100 pounds (Figures 21). The limited amount of erosion appears to be due to flowpath modification and increased roughness from the contour ripping (Figure 22 and 23).

**Figure 21.** Deposited sediment in fence #5.

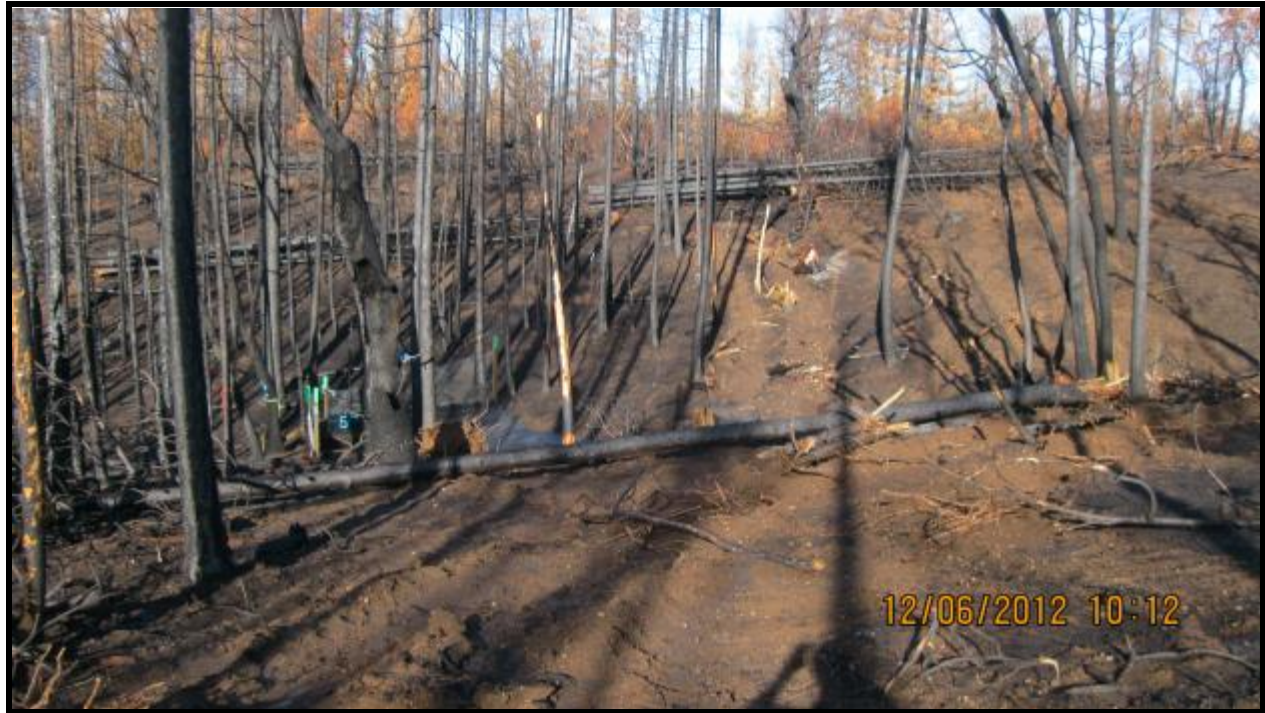
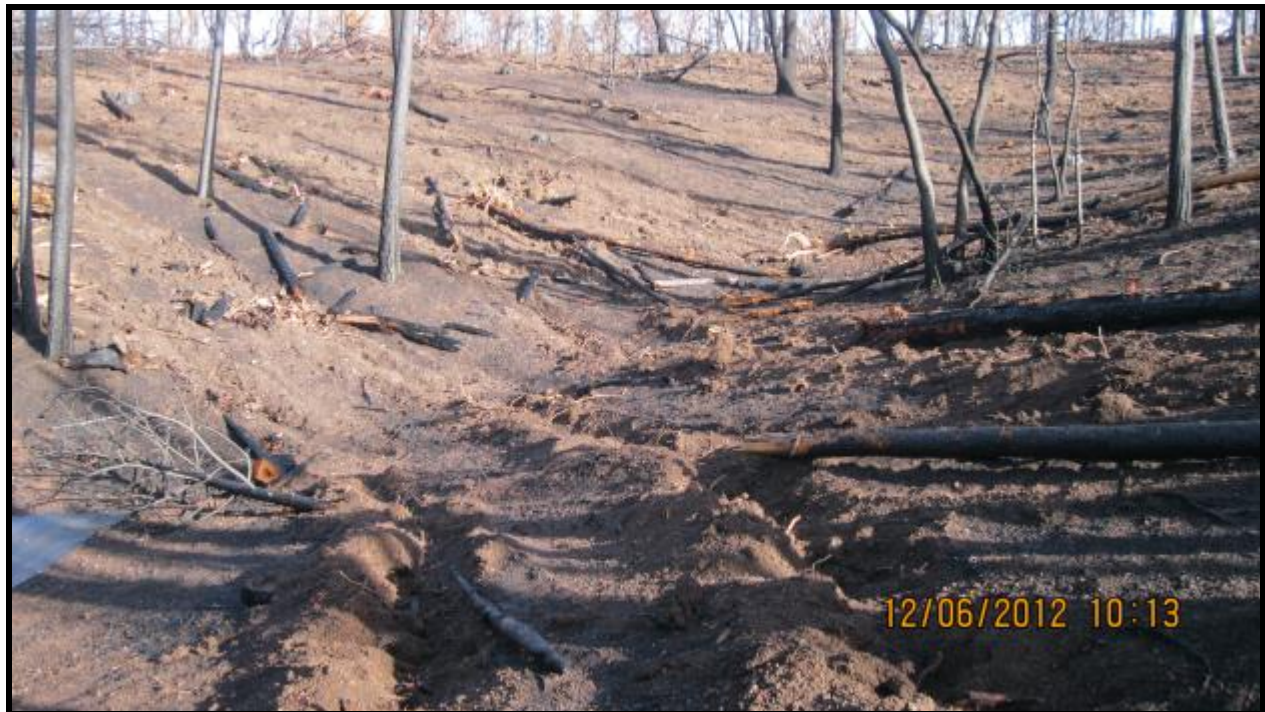
**Figure 22.** Contour ripping above fence #5.

**Figure 23.** Contour ripping above fence #5.
