## Central Valley Regional Water Quality Control Board

**Date:** 2/20/13

**Subject:** Inspection of Sierra Pacific Industries' Ponderosa Post-Fire Sediment Study, Shasta County, California

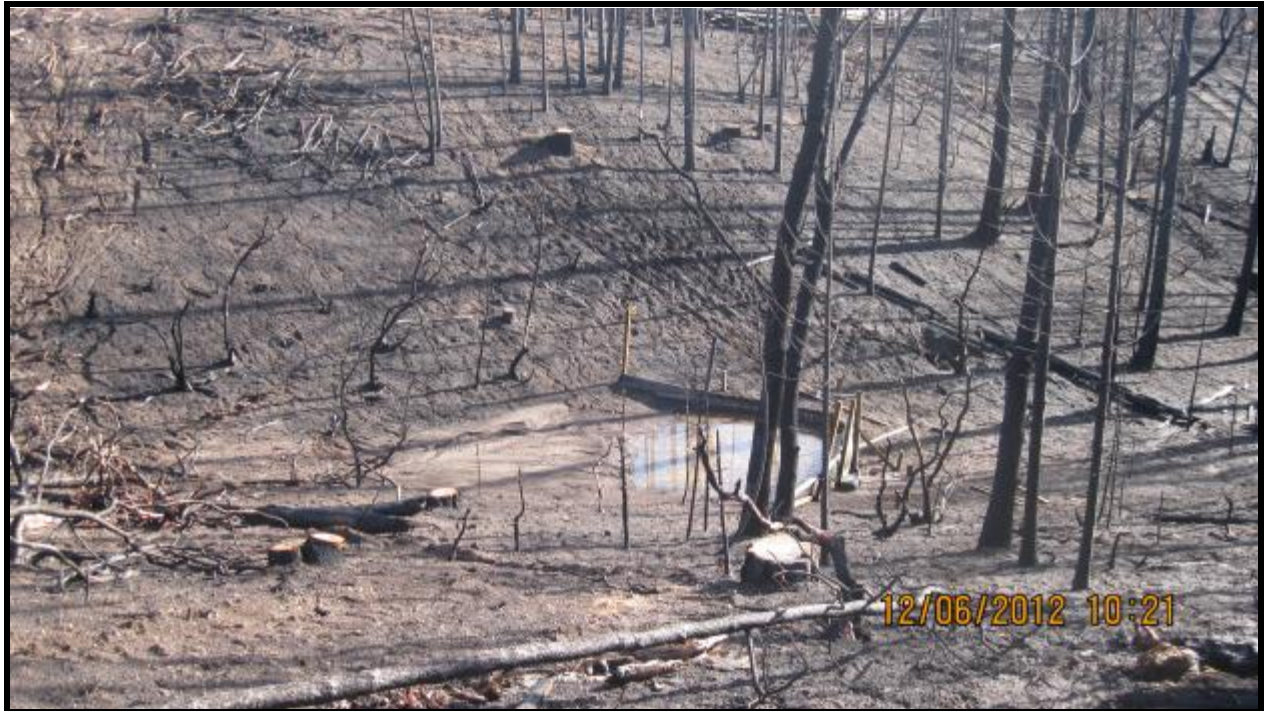
**Fence #4 (Logged and Clearcut)** - The mass of deposited material in the fence was estimated at more than several hundred pounds (Figures 24). The hillslopes above the fence were more disturbed by logging equipment than fence #6 (Figure 25). I also observed more rill erosion on the steeper hillslopes directly adjacent to the fence (Figure 24). The tracks of the logging equipment appeared to disrupt the flowpaths on the hillslopes at the head of the swale. There were fewer equipment tracks on the steeper hillslopes at the base of the swale, and the ones observed went down the fall line of the hillslope (Figure 26).

**Figure 24.** Deposited sediment in fence #4. Note the rilling on the hillslope directly above sediment deposit.

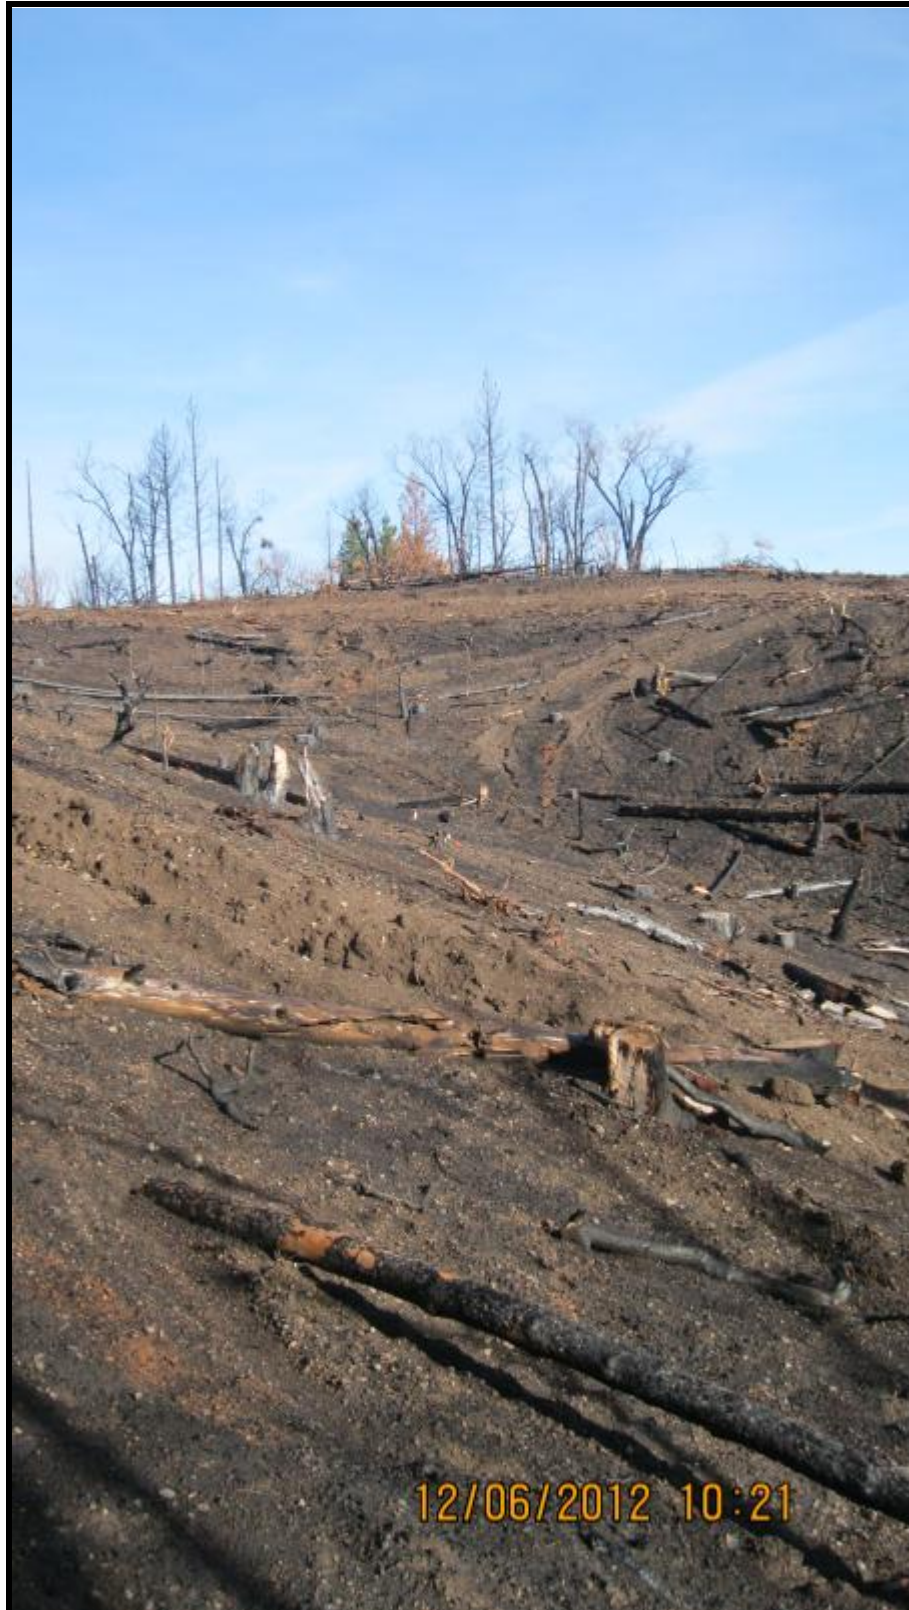
**Figure 25.** Equipment tracks on the upper portion of the swale draining to fence #4.

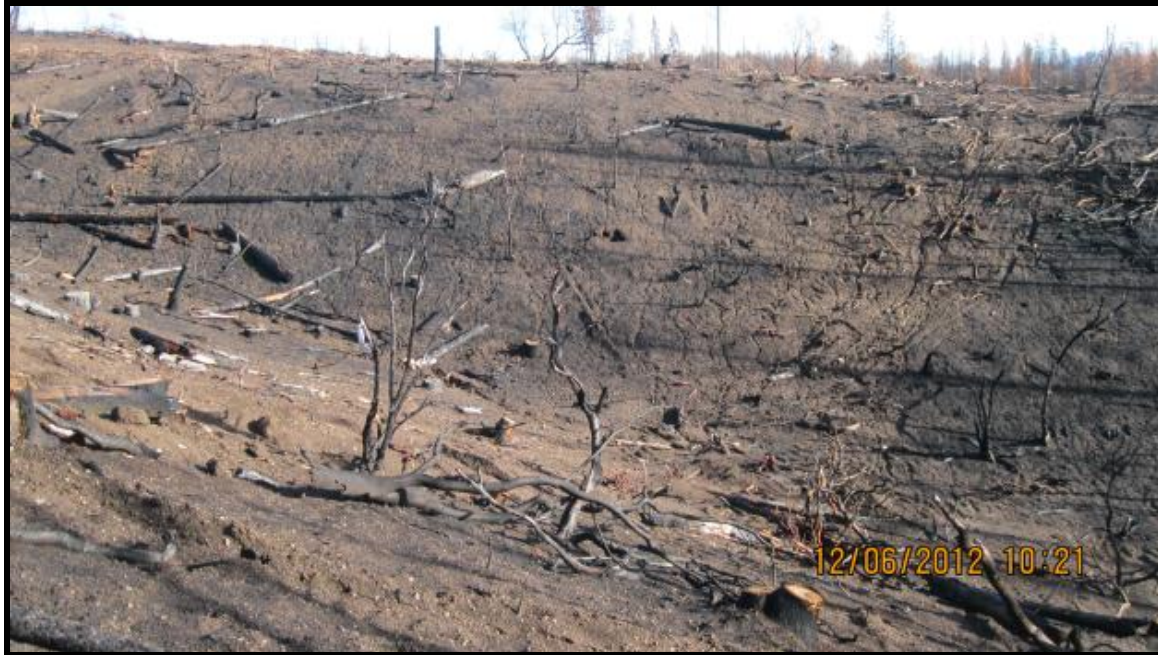
**Figure 26.** Limited skidding occurred on the steeper, lower portion of the swale. Rill erosion is observable on these hillslopes and may account for the majority of deposited sediment in the fence.

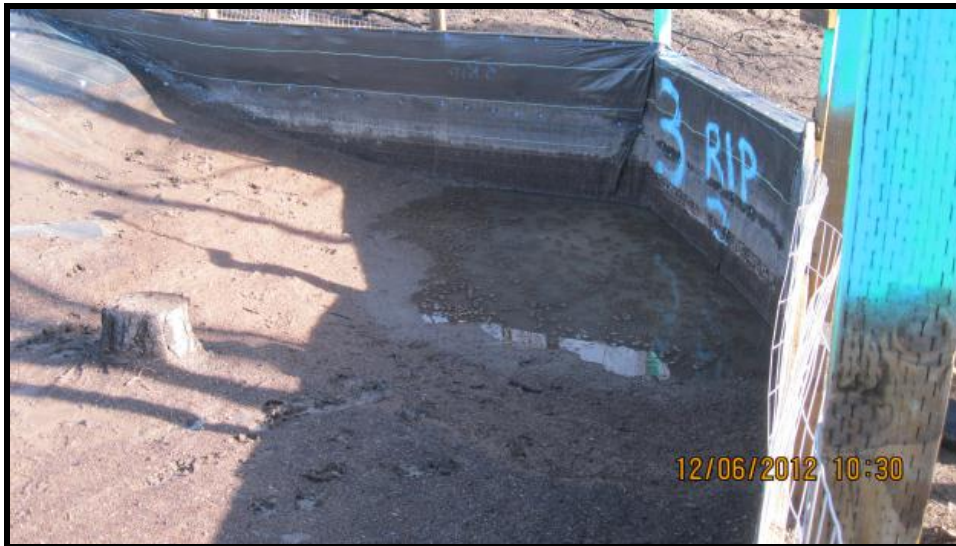
**Fence #3 (Logged, Standard Salvage, Contour Ripped)** - The deposited material in the fence was estimated between 100-200 pounds (Figures 27). The limited amount of erosion appears to be due to flowpath modification and increased roughness from the contour ripping.

**Figure 27.** Sediment deposition in fence #3.

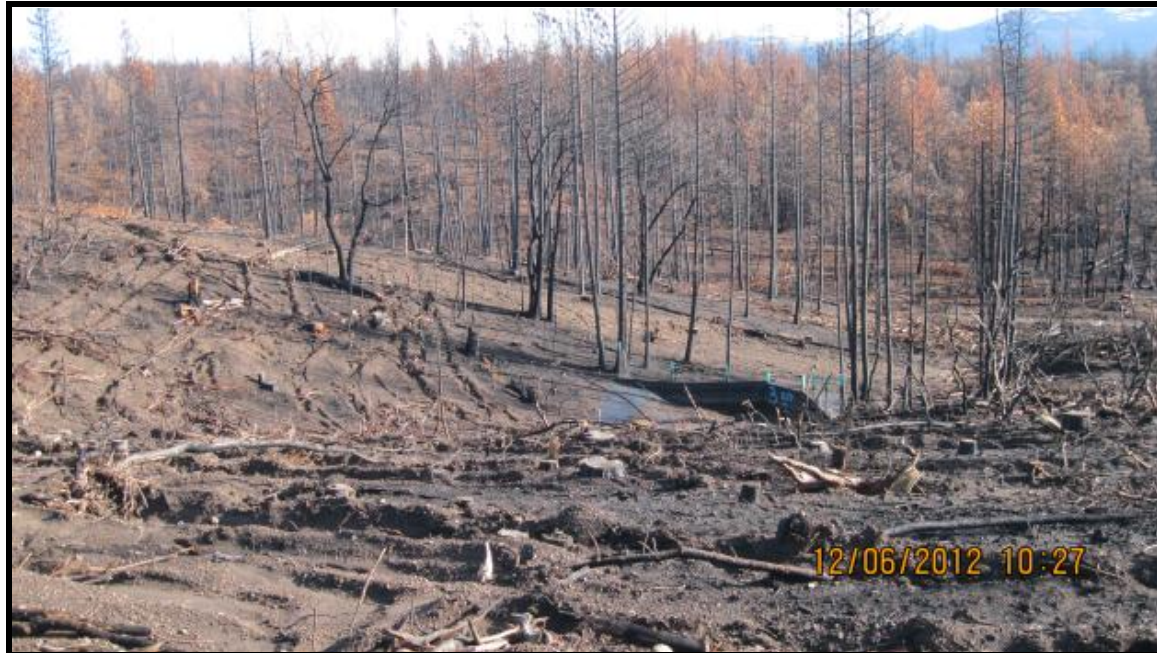
**Figure 28.** Contour ripping in the lower portion of the swale draining to fence #3.

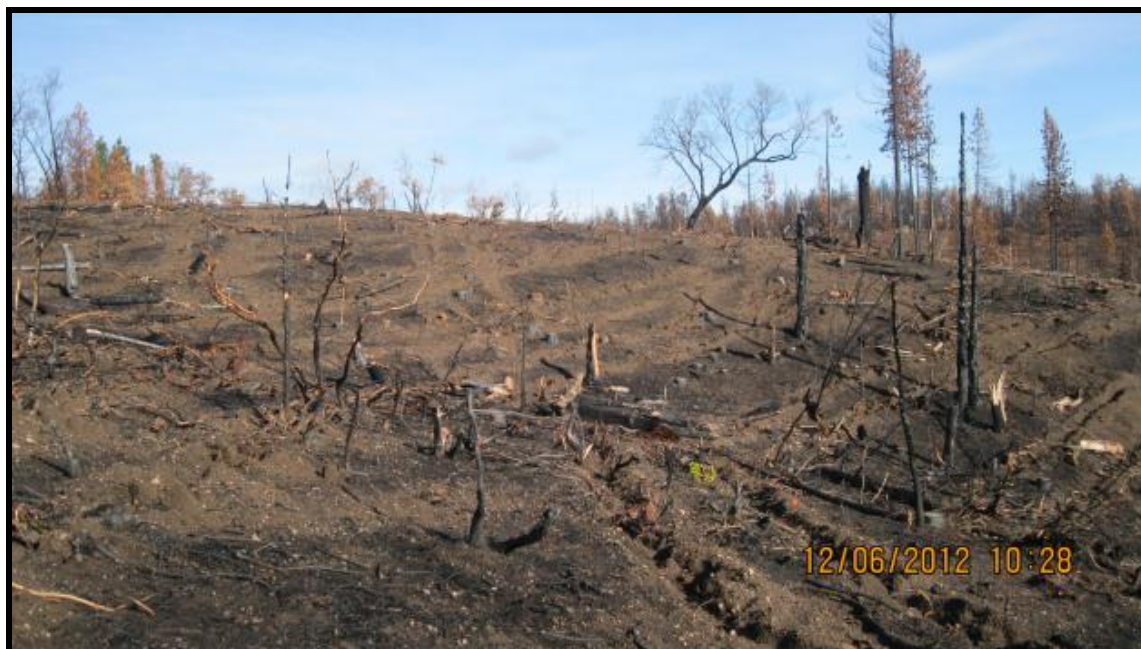
**Figure 29.** Contour ripping in the upper portion of the swale draining to fence #3.

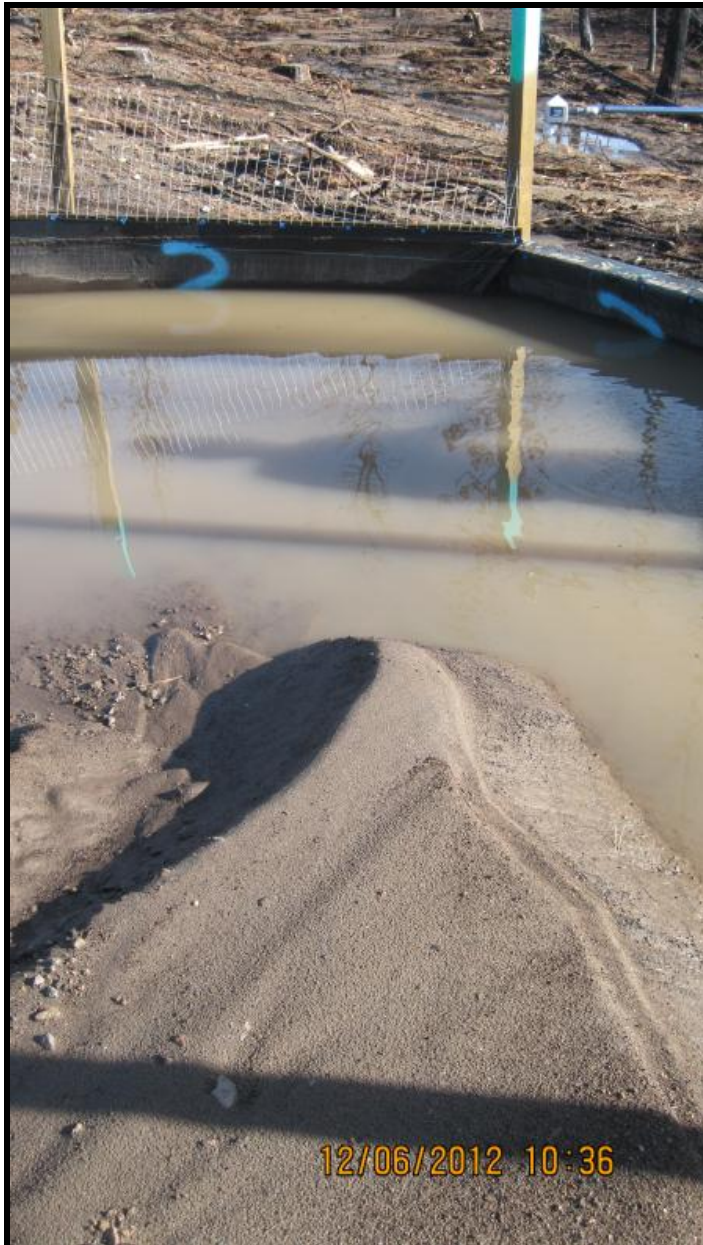
**Fence #2 (Logged and Standard Salvage)** – The mass of deposited material in the fence was estimated at several hundred pounds (Figures 30). The hillslopes above the fence were appeared to be minimally disturbed by logging equipment (Figures 31 and 32), and I did not observe significant alteration of hillslope flowpaths from equipment tracks. I observed mostly sheetwash erosion and some minor channel incision.

**Figure 30.** Sediment deposition in fence #2.

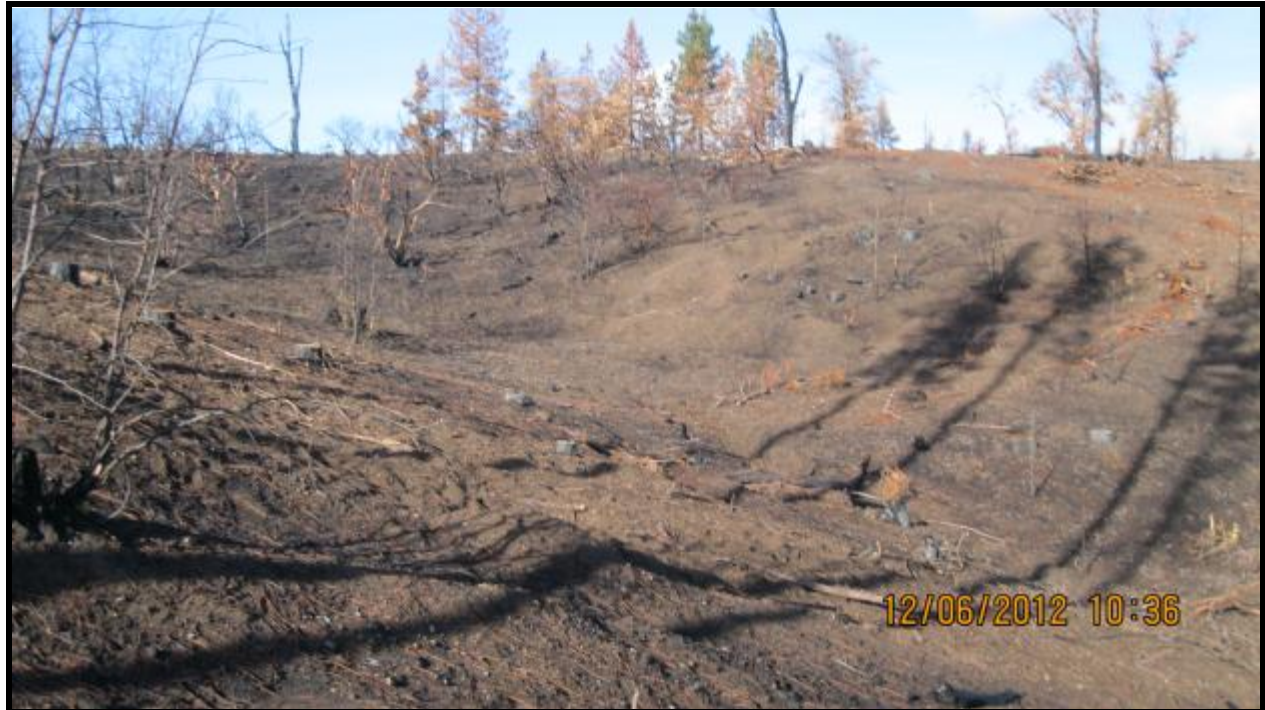
**Figure 31.** The upper portion of the swale draining to fence #2.

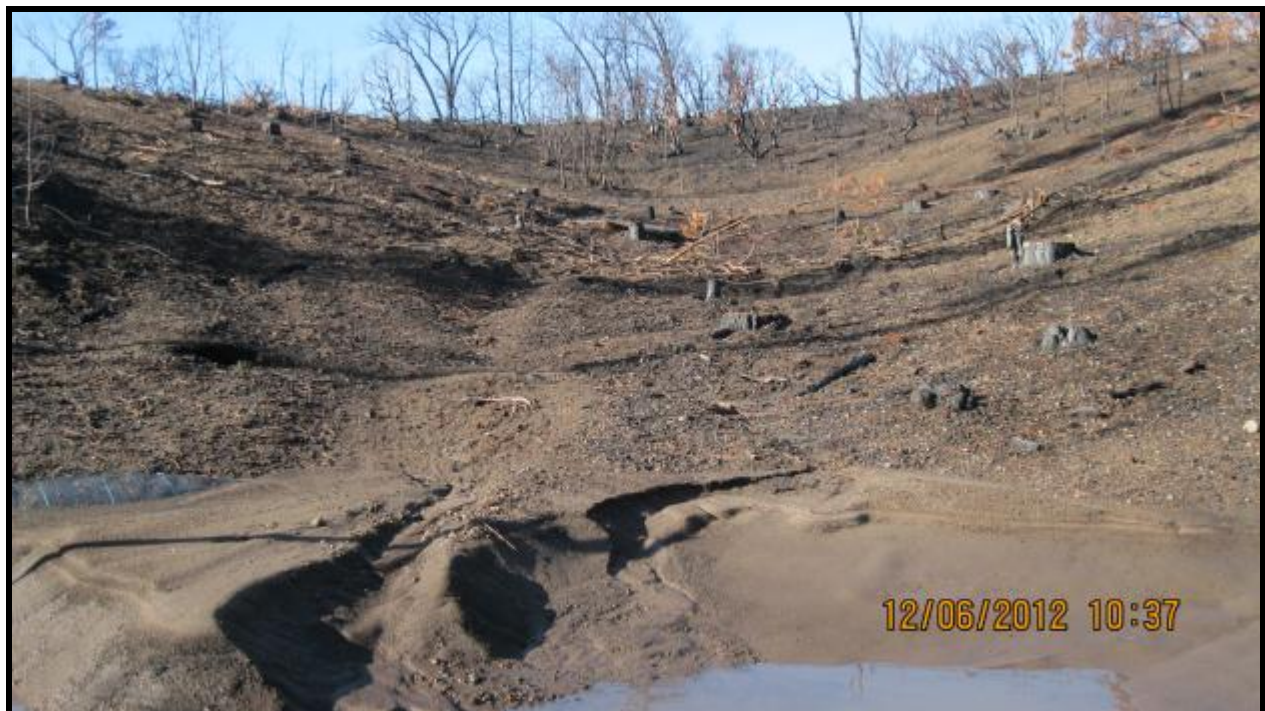
**Figure 32.** The lower portion of the swale draining to fence #2.

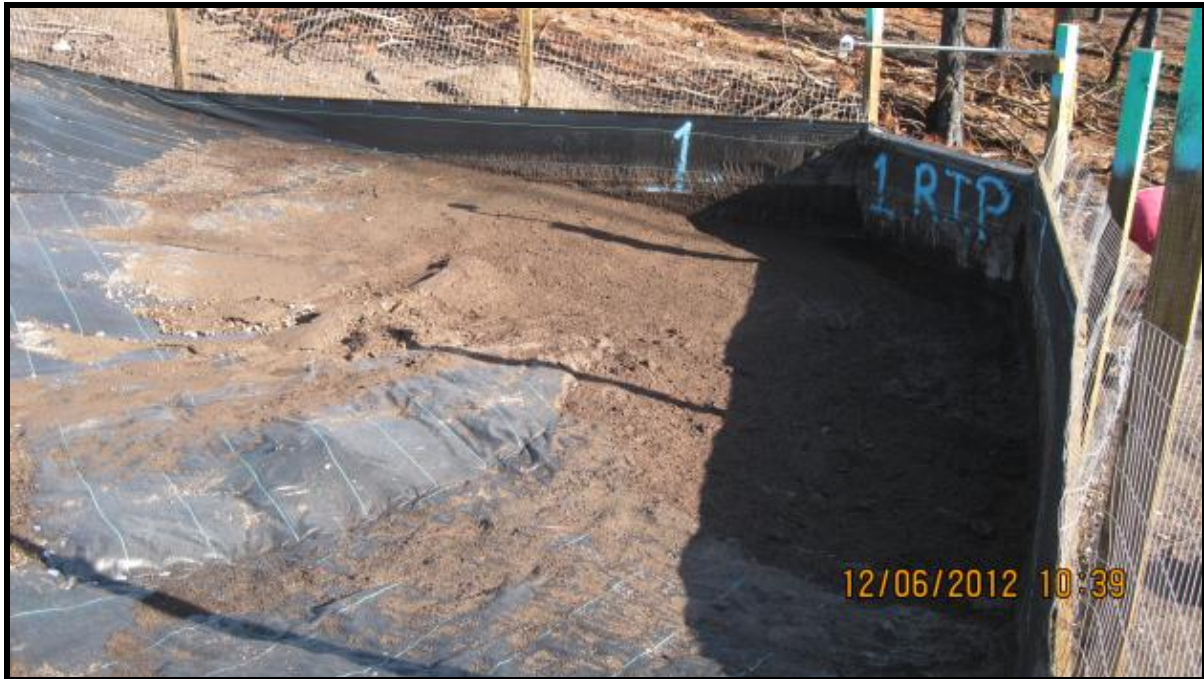
**Fence #1 (Logged and Ripped)** - The deposited material in the fence was estimated between 100-200 pounds (Figure 33). The limited amount of erosion appears to be due to flowpath modification and increased roughness from the contour ripping (Figure 34).

**Figure 33.** Sediment deposition in fence #1.

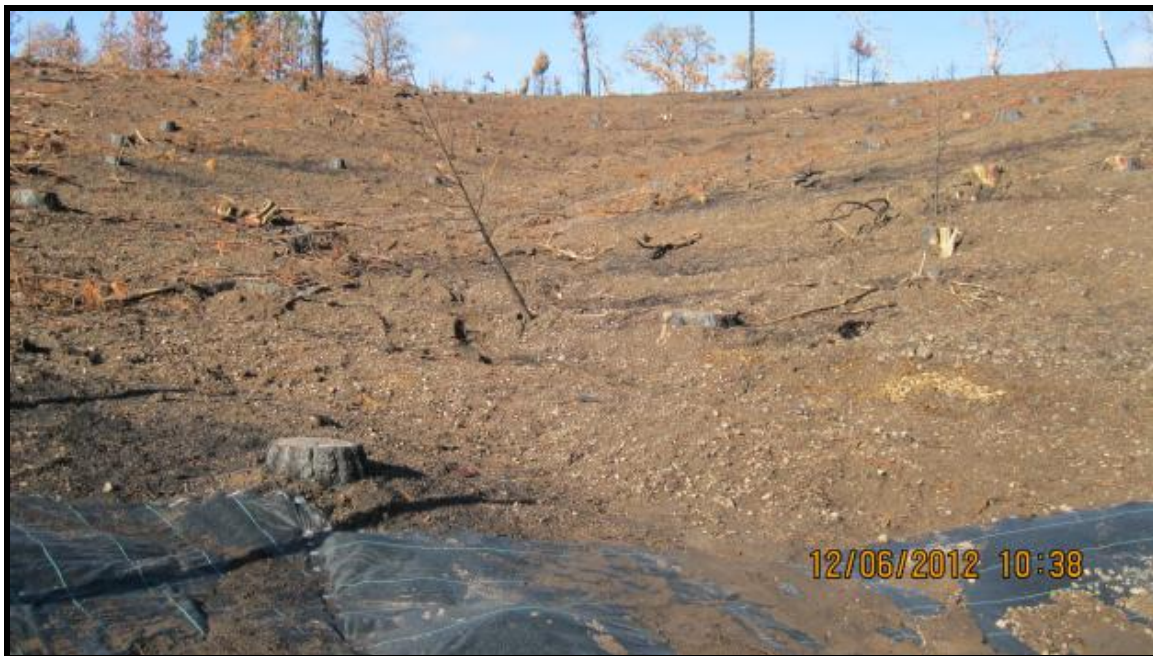
**Figure 34.** Contour ripped swale above fence #1.
